Hartford, Illinois

AERIAL PHOTOGRAPHIC ANALYSIS OF

THE CHEMETCO, INCORPORATED, FACILITY

J. S. Duggan Environmental Programs Lockheed Engineering and Management Services Company, Inc. Las Vegas, Nevada 89114

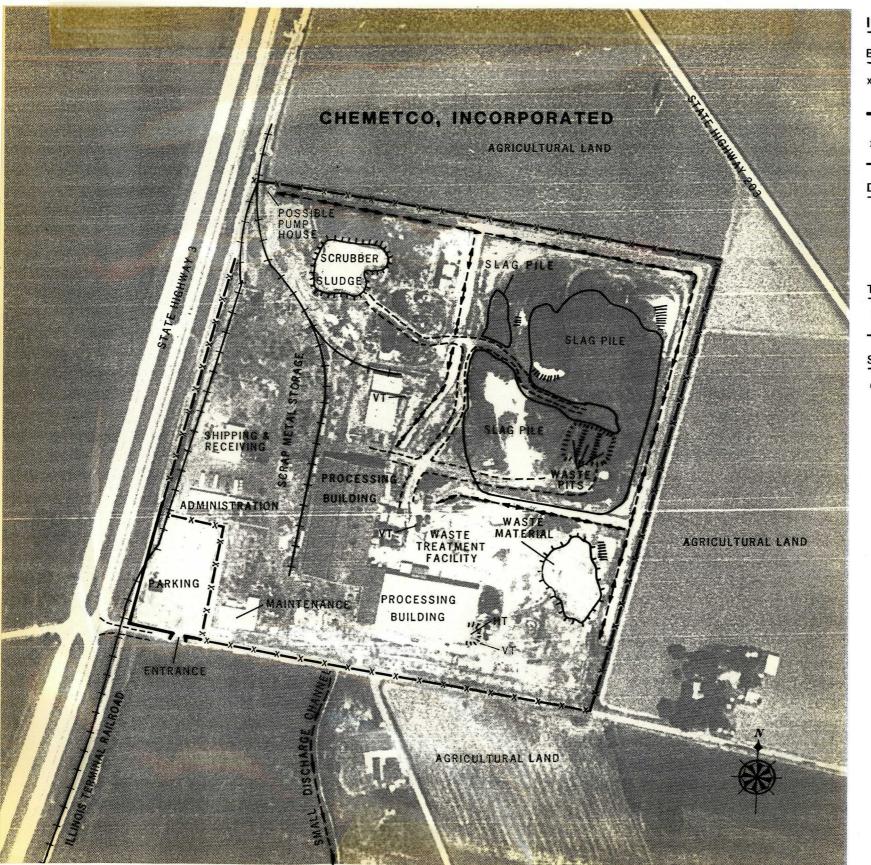
Figure 3. Chemetco, Inc., June 10, 1978. Approximate scale, 1 inch equals 275 feet.

JUNE 10, 1978

The Chemetco facility, located two miles south of Hartford, Illinois, occupies about 40 acres adjacent to State Highway 3 and the Illinois Terminal Railroad. There are two rail spurs into the facility and a single road entrance along the south boundary. The predominate features of the site are the large slag piles, the processing buildings, a waste treatment area, two small mounds, and a 30-foot wide ditch. There are two small vertical tanks and one horizontal tank present. Only the horizontal tank appears contained.

The slag pile is about 6 acres in size in the northeast corner of the site. There are three 40 by 95 foot waste pits near the center of the pile with the dumping point at the south end of the pit. A small 0.5-acre mound of possible scrubber sludge is located in the northwest corner of the site while a similar sized pile of probable waste material can be seen in the southeast corner.

A 30-foot wide ditch extends across the north boundary and along most of the east boundary. Two other ditches extend from the center of the site to the north and to the east. A possible pump house is present at the west end of the north ditch. The flow of liquid in the ditches cannot be determined as there are no indications such as slope or wave action. A portion of the liquid is very light in tone indicating the possible presence of contaminants. The total length of all the ditches is 3,535 feet.

A single small drainage channel is evident in a field south of the site which may be used for discharge of waste liquid from the site. This channel is connected to Long Lake.

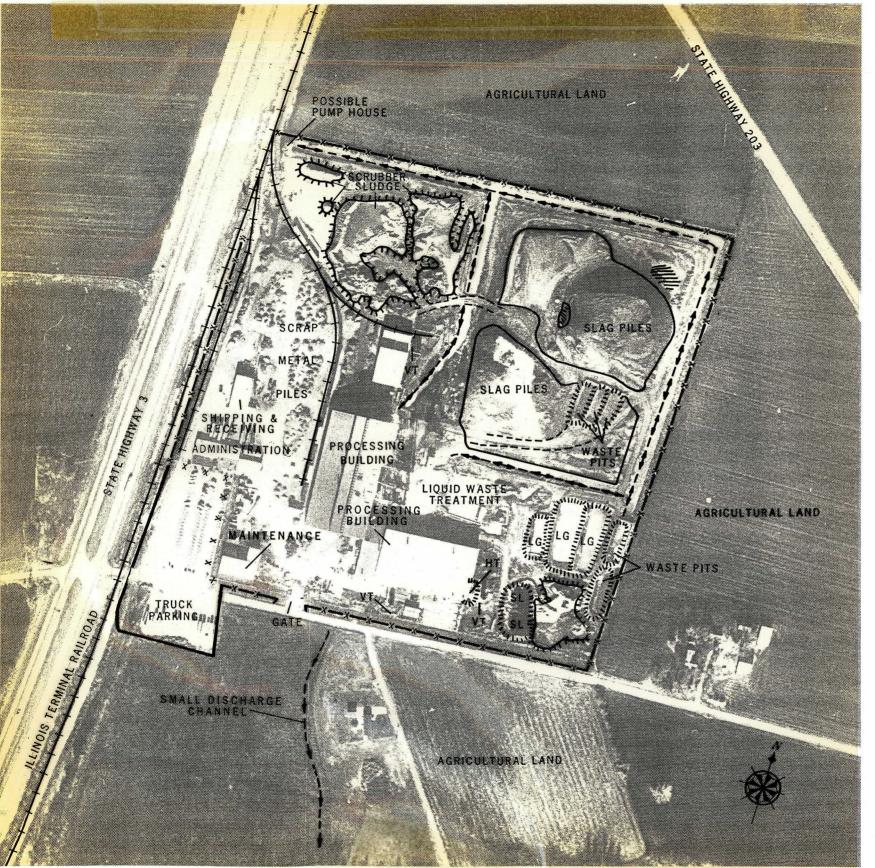
Figure 4. Chemetco, Inc., December 14, 1980. Approximate scale, 1 inch equals 275 feet.

Analysis of the 1980 photographs reveal only a very small increase in size in the site but some significant changes within the site. In the southwest corner across the road which is the south boundary of the site fill material has been brought in to create a truck parking area. This area is about one acre in extent so the facility now is about 41 acres.

Within the site the slag piles in the northeast corner are slightly larger and higher. The three waste pits are still present and appear to contain some waste material. The scrubber sludge pile in the northwest corner is much larger indicating continued processing activity at the site. In the southeast corner of the site three lagoons have been built. The largest of these is approximately 220 by 80 feet while the smallest is 110 by 55 feet. A portion of the adjacent ditch has been converted into two waste pits eliminating approximately 275 feet of the ditch. Both of these pits contain waste material. To the south of the lagoons there is a mound of material and an adjacent pool of liquid which is surrounded by a dike. A third vertical tank is present but does not appear to be contained.

The remainder of the site appears much as it did in 1978 with the exception of the prominent new entrance along the south boundary. The small discharge channel is still present but it is not possible to confirm if any liquid is present.

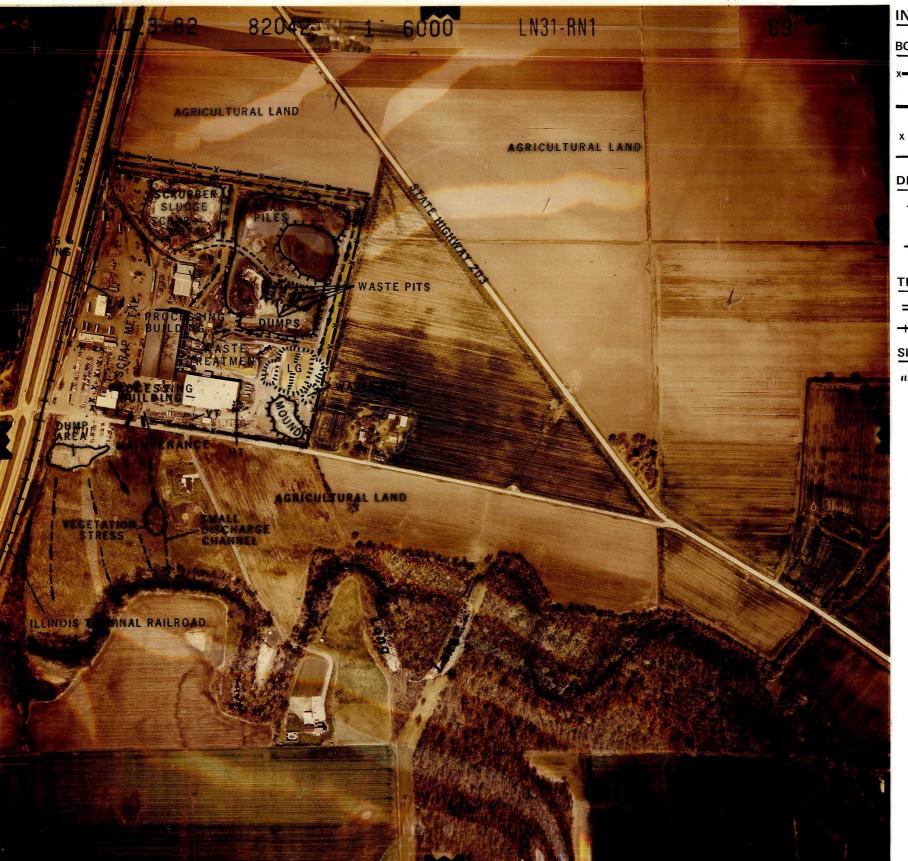
Figure 5. Chemetco, Inc., April 23, 1982. Approximate scale, 1 inch equals 500 feet.

Analysis of the color aerial photographs reveal several small changes in the overall appearance of the site. The slag piles have grown in size to about 8 acres while the scrubber sludge piles are about 2.6 acres. A fourth waste pit has been added in the slag pile area but it appears to be open at the north end.

The waste lagoons all contain liquid while the two adjacent waste pits appear full. The mound present in 1980 is slightly smaller in 1982 and the adjacent pool of liquid has either been removed or has been covered over. The shipping/receiving area, the processing buildings, waste treatment area, and the maintenance area remain the same as in 1980.

The area south of the main facility that was a parking lot area has been expanded by about 1 acre and appears to be used for dumping of waste material. Drainage from this dump area is south toward Long Lake. A small area (150 by 100 feet) adjacent to the discharge channel appears to have suffered some vegetation stress.

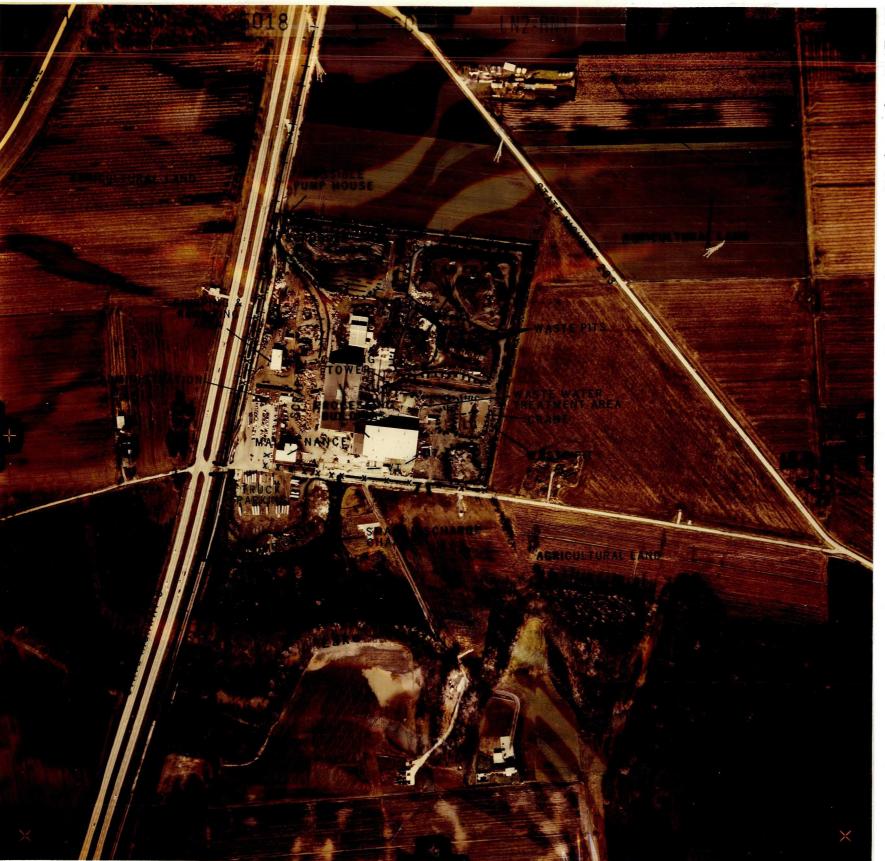
Figure 6. Chemetco, Inc., November 28, 1984. Approximate scale, 1 inch equals 500 feet.

The color aerial photographs of November 28, 1984, reveal continued activity at the Chemetco facility. There appears to be more scrap piles in the shipping and receiving area. The scrubber sludge piles have grown and two bodies of liquid are visible. These pools of liquid total about 1.35 acres. The slag piles remain much the same as in 1982 and there are still four waste pits within the piles.

In the southeast corner the large lagoon still contains liquid but the smaller lagoon now appears to be filled with solid material. The two waste pits east of the lagoons appear full but it appears from the presence of an excavation crane that one of the pits is being emptied. Near the center of the site adjacent to the processing building and the waste treatment area, there are two cooling towers constructed since the overflight of 1982.

The dump area to the south of the site has been expanded further out into the adjacent field. This adds another 3 acres to the site, increasing the overall site size to about 45 acres. The different tones of the material in the dump indicates a variety of wastes are present. Drainage from this area is toward the south and Long Lake.
